# Aviation Investigation Final Report

<b>Location:</b>	San Diego, California	<b>Accident Number:</b>	WPR21LA110
<b>Date &amp; Time:</b>	February 13, 2021, 11:50 Local	<b>Registration:</b>	N823RC
<b>Aircraft:</b>	Dassault Falcon900EX	<b>Aircraft Damage:</b>	Substantial
<b>Defining Event:</b>	Runway excursion	<b>Injuries:</b>	5 None
<b>Flight Conducted Under:</b>	Part 91: General aviation - Personal

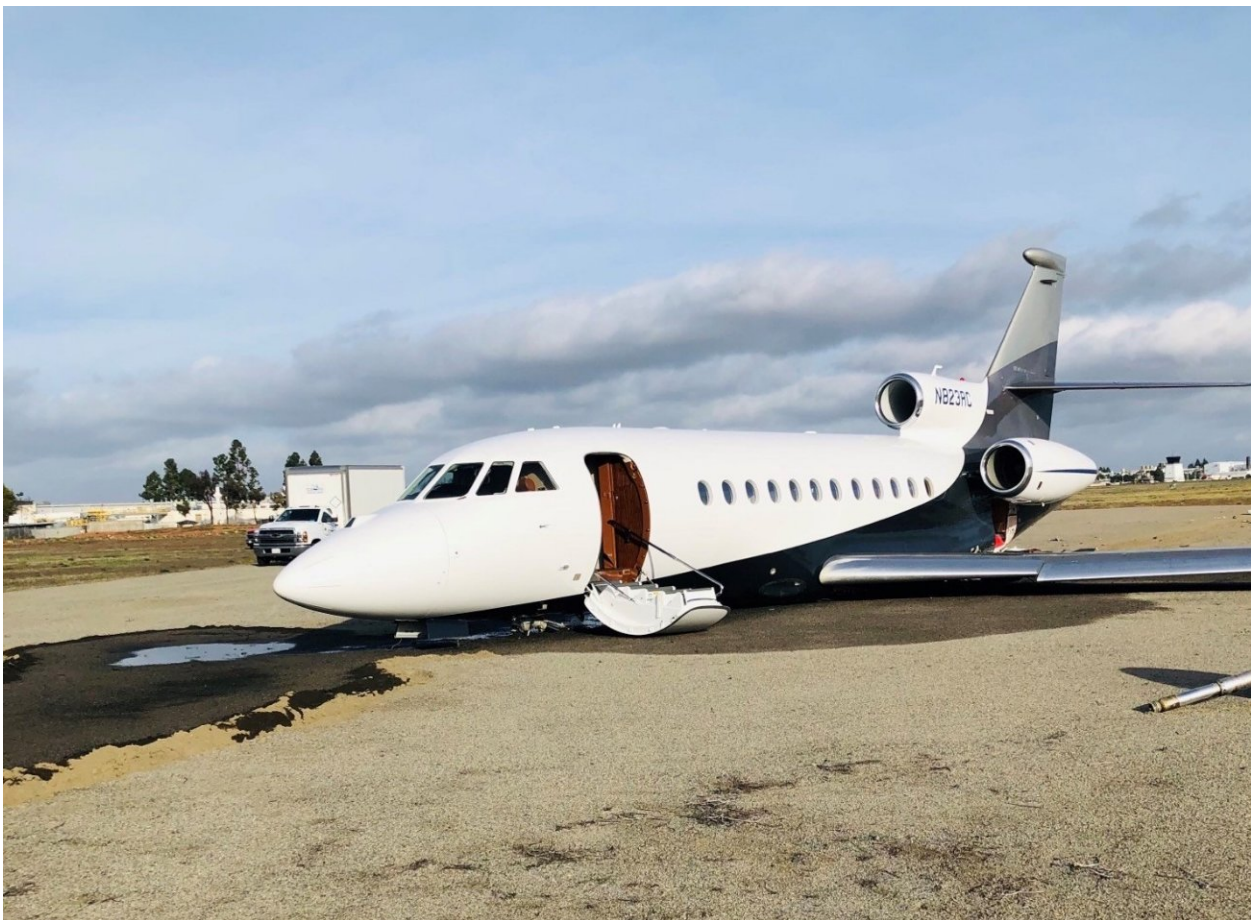
The airplane overran the departure end of the runway by about 315 ft and struck a berm, which sheared off all three-landing gear. The airplane slid an additional 230 ft and came to rest on a gravel overrun pad. The airplane sustained substantial damage to the wings and fuselage, and the fuel tanks were ruptured (see figure). Continuity was confirmed from the flight controls to the control surfaces, and significant fuel leakage was present, but no fire ensued.

Figure - View of Airplane Damage (Source: FAA)
